Restoration Towards Sustainable Green Heritage Buildings, Case Study: Mansoura Opera House, Mansoura, Egypt

4.2 Case study: Municipal Council (Mansoura Opera House):

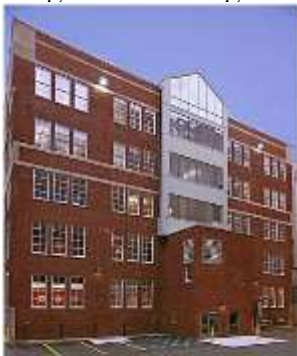
A: In 1928

The six-story Administrative building as shown in **Pic. (2), A, B, C, D, E, F**, with Elizabethan-revival style and brick and limestone cladding front as shown in **Pic. (2A)**, the entrance at the southwestern corner was restored and had the blue stoned floor and multi-colored wall. The restoration process intended to show the contrast between old and new where other materials were used like glass and wood for the doors on the first floor.

- In order to improve the environmental performance of location and decrease use of fuel emission from transportation to and out of the building, as shown in **Pic. (2A)**, there are a number of bus lines to the area to serve as substitutes to personal transportations. Boosting use of bikes by providing bike racks. Lockers and showers were provided to help individuals to walk or run to work. Parking lots were provided to be reserved preferably by fuel competent personal transportations.

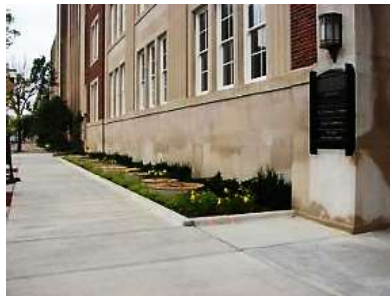
Pic. (4) Sustainable sites

- For sustainability consideration, the old millstones of the building's sidewalk were removed sensibly and applied to the front façade, as shown in **Pic. (4)**.

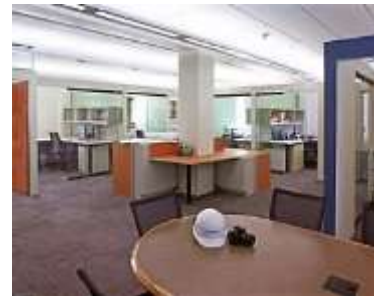
Pic. (5): Energy and internal atmosphere

- A white roof was installed to reduce heating and light pollution was minimized by using solar power LED systems.
- Energy effective systems that include; occupancy sensors, energy star rated computers and refrigerators, use displacement ventilation, water heating system was energy efficient by 20%, low ceiling height and downward directed light as shown in **Pic. (5)**.

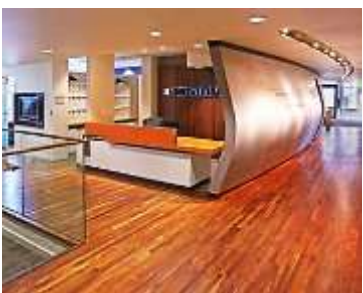
Pic. (6): Finishing's materials

- Using materials and resources that are eco-friendly where refrigerators and coolers used minimal ozone depleting systems, use biodegradable materials and encourage recycling by having a coordinator of recycling and designing in-house recycling system that includes labeling the bins, use only low mercury emission lamps as shown in **Pic. (6)**.

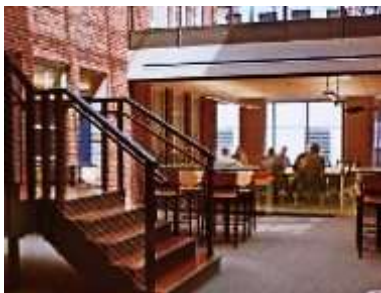
Pic. (7): Indoor environmental quality

- The indoor environmental quality aimed to lower toxic wastes and controlling pressure, humidity and most of all a continuous process of evaluation that ensures that the aims of the design are achieved as shown in **Pic. (7, 8)**.

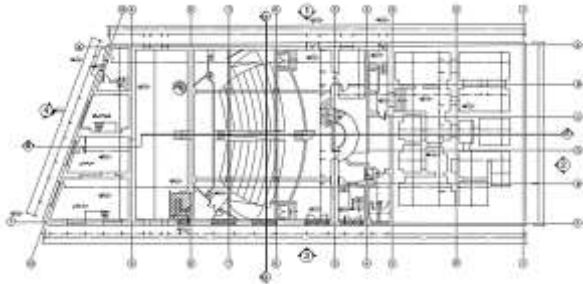
Pic. (11): Basement Floor plan

It is a cuboid building with a rectangular floor plan shows four free facades, consisting of three floors as shown in Pic. (11, 12, 13, 14, 15, 16). Mass composition, the design of facades and pattern of void reveals its neo-classic style.

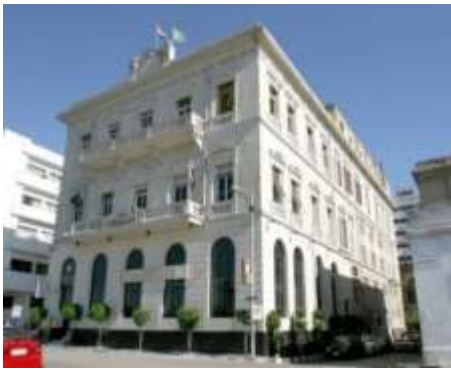
Pic (17): Main and eastern façade in 2004.

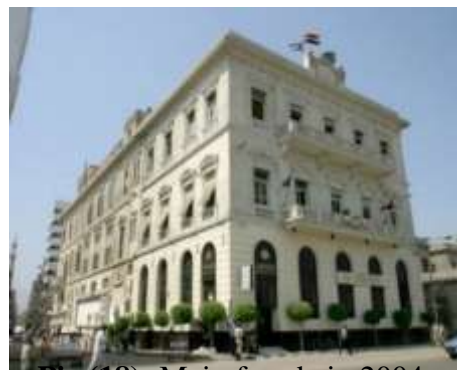
Pic (18): Main façade in 2004.

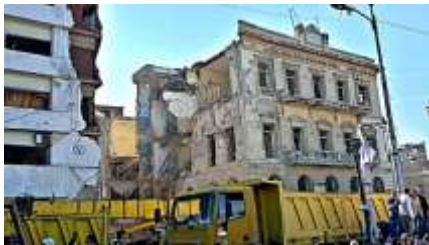
On the 24th of December, 2013, night a terrorist explosion occurred in Al-Dakahlia Security Directorate adjacent to Mansoura opera house building, in which 11 people were killed and about 100 others were injured. The building was destroyed as shown in the following **Pictures (21, 22, 23, 24, and 25)**. The renovation works of the opera house were carried out by national companies and work is still in progress as shown in **Pic. (26,27)**. The repairs and rebuild carried out by Arab contractor's company and was based on studies that relied on restoration only and not take in account the fact that the building is a historical building registered on the lists of National Authority for Civilizational Coordination as a heritage building in the province of Dakahlia.

Pic (21): The main and eastern Façade with the entrance of the opera house was destroyed in 2014

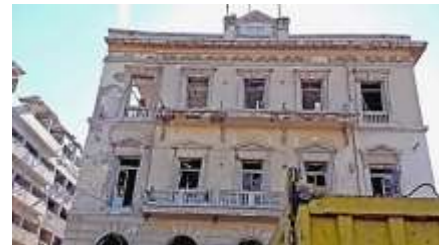
Pic (22): The fully destroyed front Façade in 2014

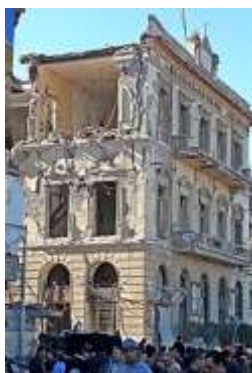
Pic (23): Building destruction in 2014

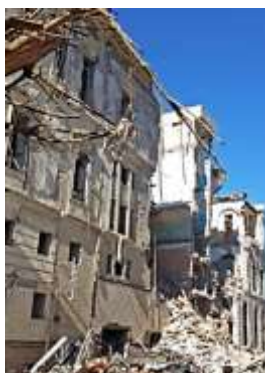
Pic (24): Remains of eastern facade in 2014

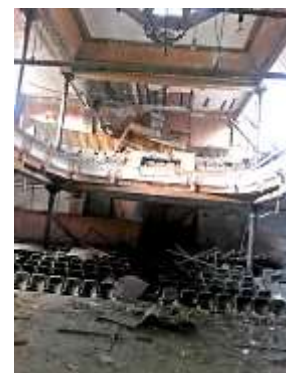
Pic (25): The opera atrium after destruction in 2014

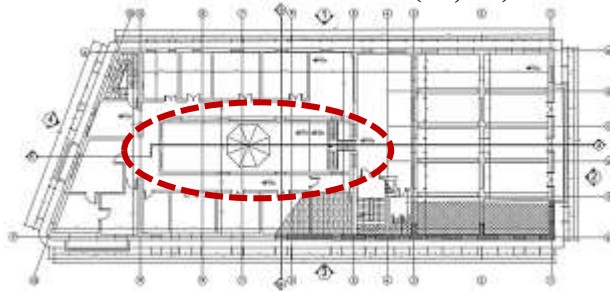
Pic. (28): First Scenario: increasing natural daylighting by expanding the inner courtyard in the second Floor plan

Based on the preliminary studies held by the contracted company and with the application of Sefaira software researchers [18] suggest two scenarios for the restoration and reconstruction as a way for greening the building by focusing on minimizing energy utilization through daylight visualization. One of these scenarios could be applied after restoring and reconstructing the building. First Scenario: expanding the inner courtyard in the last two floors to increase natural lighting through a number of recommendations as shown in **Pic. (28, 29)**.

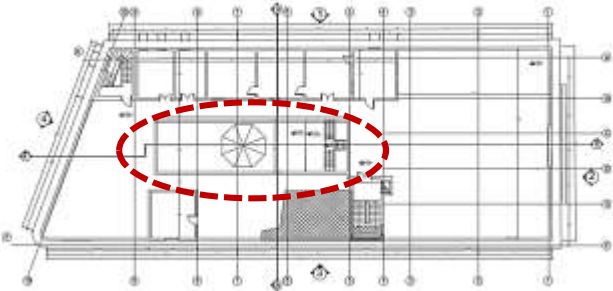
Pic. (29): First Scenario: increasing natural daylighting by expanding the inner courtyard in the last Floor plan

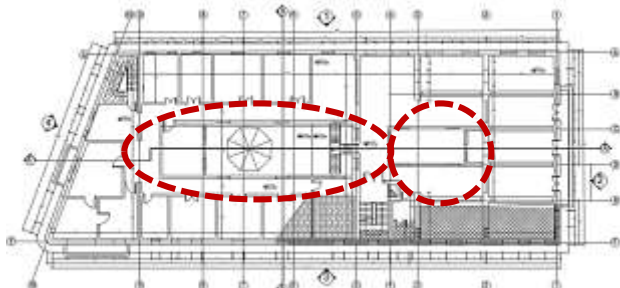
Pic. (30): Second Scenario: increasing natural daylighting by expanding the inner courtyard and adding a new courtyard to the last two floors of the building

Second scenario: expanding the inner courtyard and adding a new courtyard to the last two floors of the building to increase natural lighting through a number of recommendations as shown in **Pic. (30, 31)**.

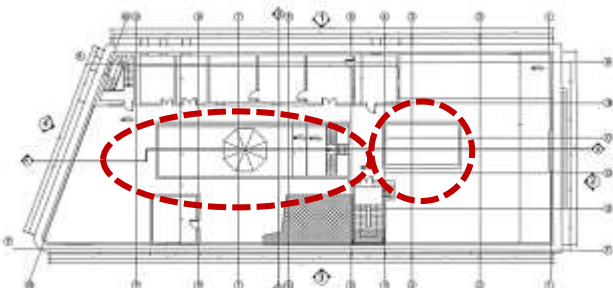
Pic. (31): Second scenario: increasing natural daylighting by expanding the inner courtyard and adding a new courtyard to the last floor of the building

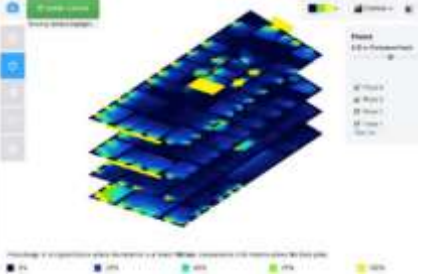
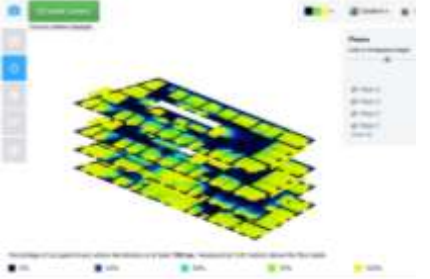
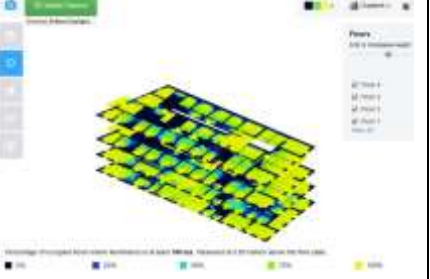
<p>The building of 4 floors and natural lighting in the current situation from current openings without any greening,</p>

<p>The degree of clarity and intensity of light are measured at an altitude of 85 cm of the ground as shown with a gradient from yellow to black</p>

Table (1) shows a comparison between the current situation of the building and the two postulated scenarios according to daylighting visualization.

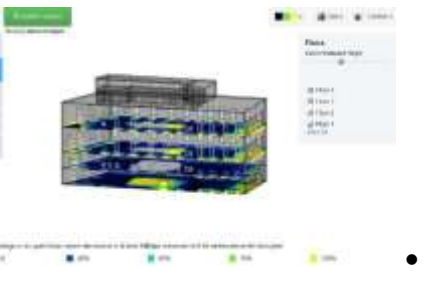
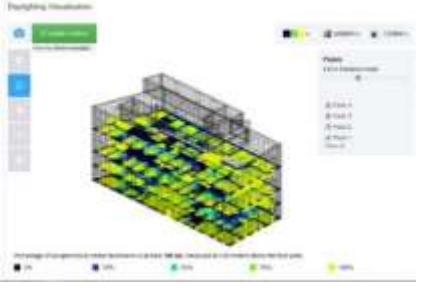
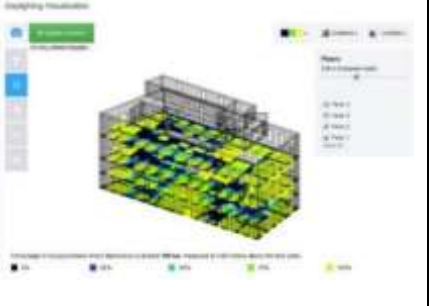
<p>Three-dimensional structure of the building, showing the windows and its proportion to the facades of the building.</p>				
Distribution of natural

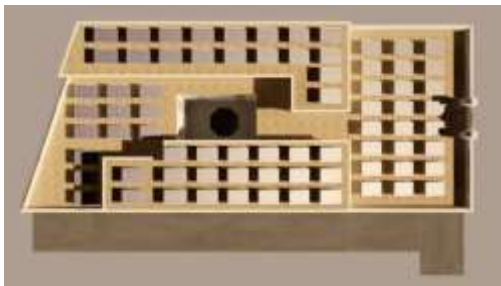
Pic. (32): lay out shows the photovoltaic cells

Researchers used Autodesk insight 360 [19] to show the significance of using solar energy through comparing current situation of the building with the situation after application of photo-voltaic cells PV on its rooftop as shown in **Pic. 32, 33**, in terms of Energy consumption, Impact on Heating Hours, Impact on Cooling Hours and Equipment as shown in **Table (2)**. Daylight visualization together with the use of sustainable energy source would be expected to improve the overall energy for the building performance.

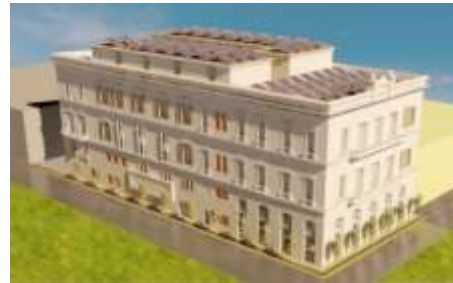
Pic. (33): virtual visualization of the green Municipal Council after using photovoltaic cells on the ceiling of the building

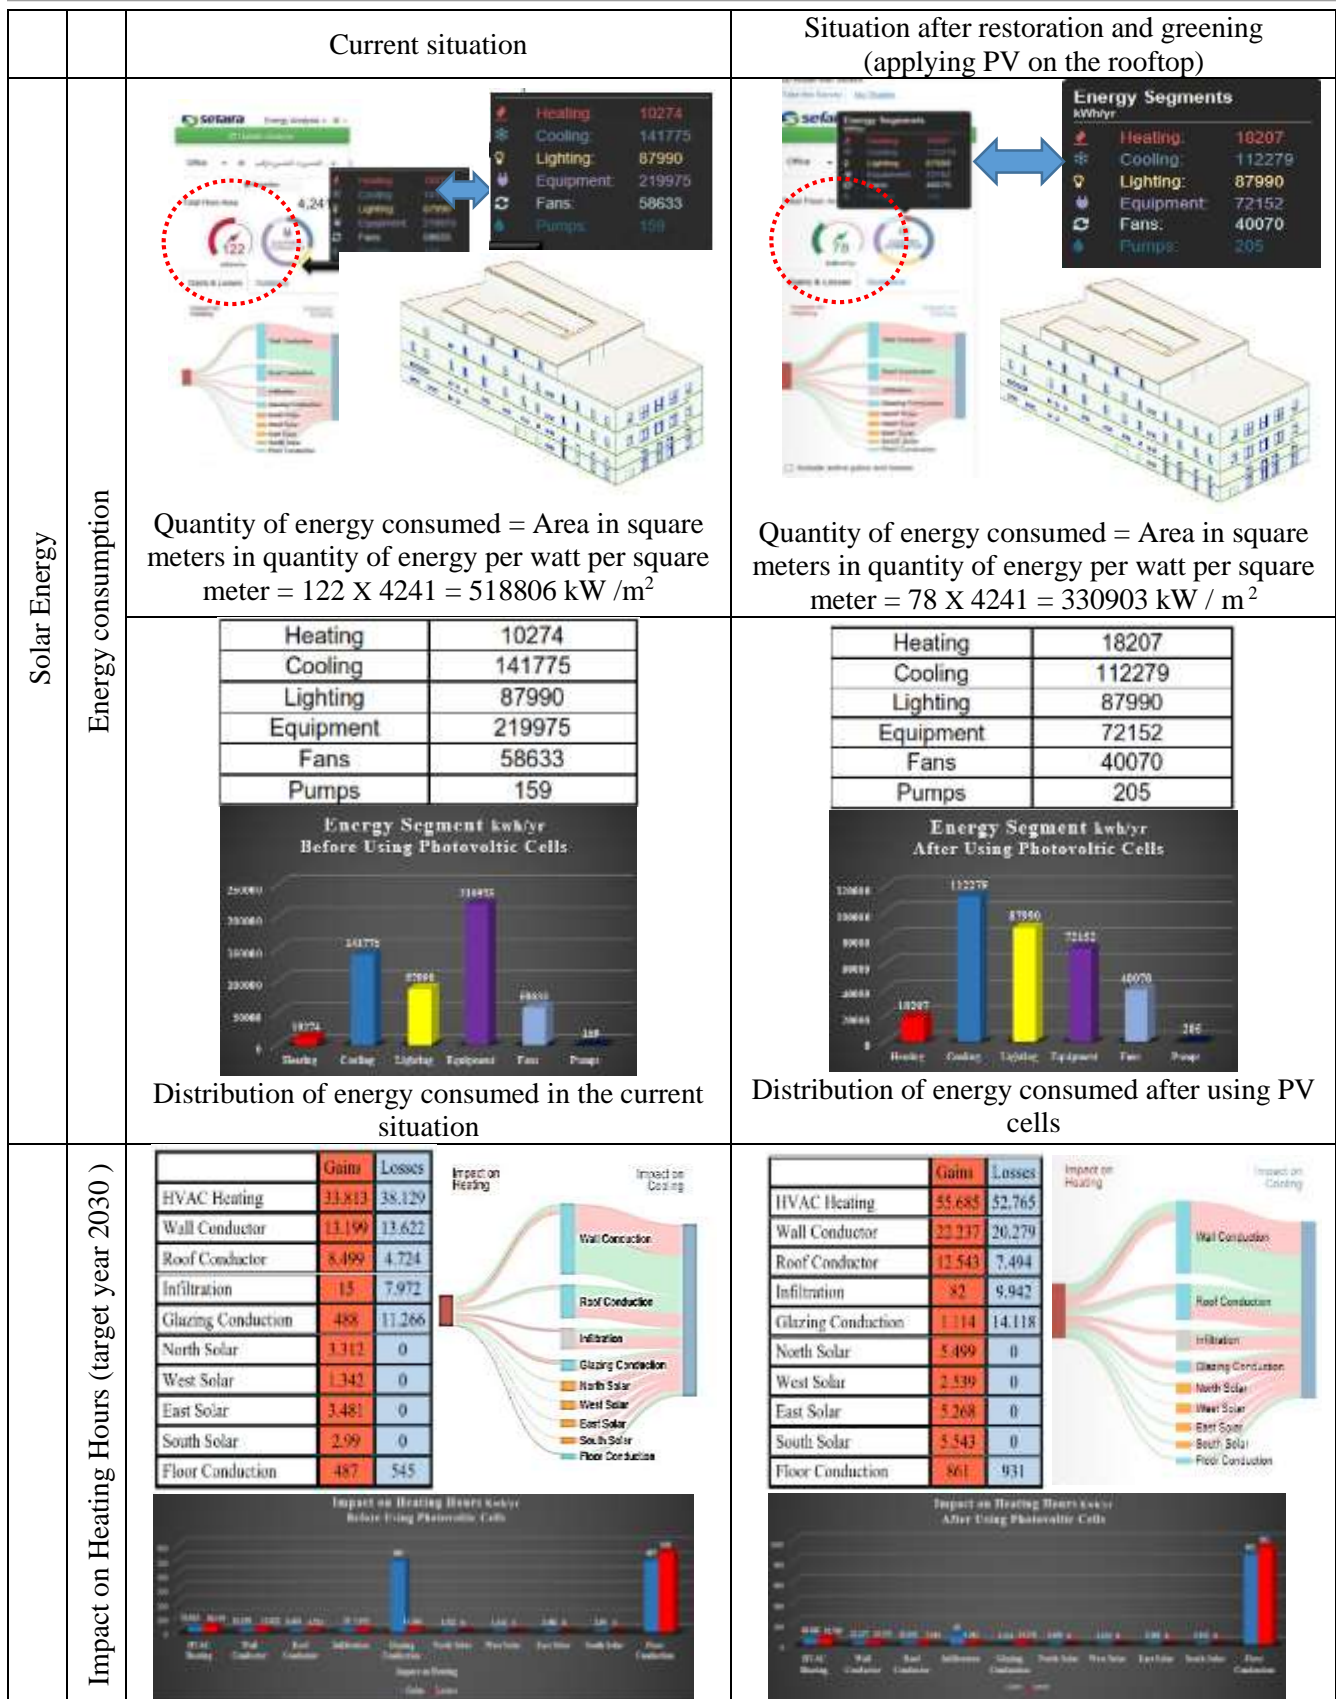
Table (2): Comparison of the Current Situation and the situation after restoration and greening

Impact on Cooling Hours (target year 2030)

- Concerning daylight visualization, the second scenario is set to be the best choice as it where it achieves the best utilization of daylight compared to the current situation and the first scenario thus will reflect itself in energy conservation.
- Analyzing data collected from Autodesk insight 360 revealed that PV cells installation on the rooftop of the building will save a total of 186604 kW/m² per year.
