# APPLYING NEW CRITERIA FOR HIGHER EDUCATION CAMPUSES TO SERVE SPECIAL-NEEDS STUDENTS, CASE STUDY: AASTMT ALEXANDRIA CAMPUS

Nancy F. Darwish\*1, Adel Samy El Menshawy 2, AbdelAziz Farouk A. Mohamed3, Fahd A. Hemeida4

KEYWORDS: Physically disabled people, Campus Accessibility, Landscape, architecture design, Special -needs rights, The Egyptian code requirements elements, Egypt, Alexandria

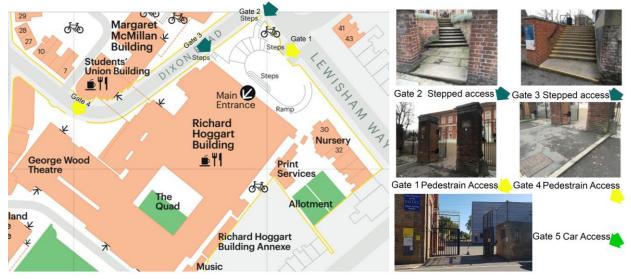
Figure (1): Main Entrance Gate [14] {15}(Edited by Author)

This information relates to the entrance on Lewisham Way that is situated in the center of the front entrance courtyard. In figure (1), this entrance has slope and stepped access. At this entrance, there is neither a canopy nor a recess that offers weather protection. There is only one door. The door is kept open all the time with opening width 170 cm.

This entrance has a ramp. In front of the entryway is the ramp. The slope or ramp has a mild gradient. The ramp is always there. The top of the ramp is not a level landing.

There are no railings on the ramp. Long slopes in both directions lead to this gate on Lewisham Way. Lewisham Way and Dixon Road both lead to alternative entries into the entry courtyard [16].

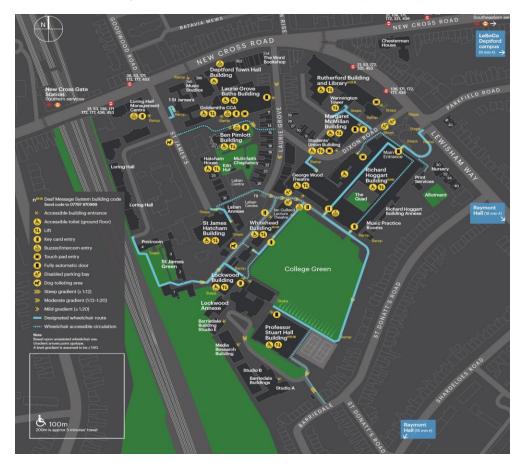
Figure (2): Goldsmiths, University of London Campus Map for Accessibility [16]

Information on entering university buildings for students with mobility difficulties. The campus is fairly small, and it takes only ten minutes to travel from one end to the other. The majority of bigger structures used for instruction have step-free entryways. Although not every building can claim to be completely accessible, with a little amount of extra preparation, no one should be precluded from fully participating in Goldsmiths activities as shown in figure (2).

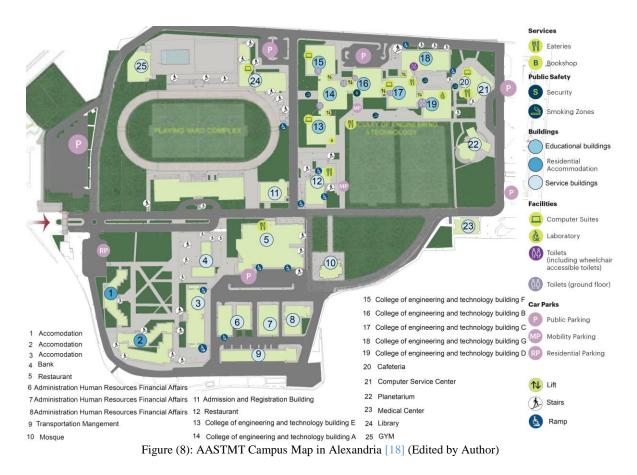
As shown in figure (8), the area is 52-acre land and located in El-Tarh in Abu Kir, Alexandria, as first location [19].

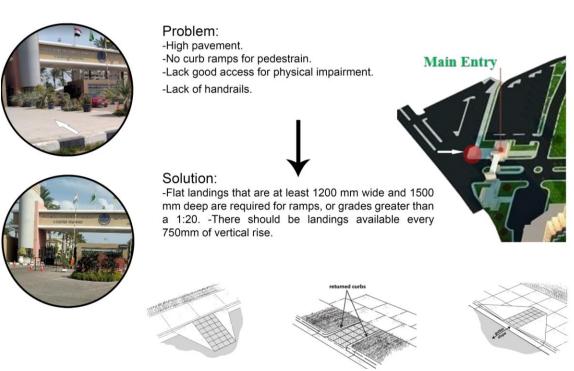
Figure (9): AASTMT's Main Entrance Gate [21][22]. (Edited by Author)

This information relates to the entrance that is situated in the center of the front entrance courtyard. This entry has car and pedestrian access. There is no curb ramps as shown in figure (9). At this entrance, a canopy offers weather protection. There are two doors. The doors are kept open all the time with opening width 5 m for each. The width of the whole gate with the pedestrian paths is 28 m.

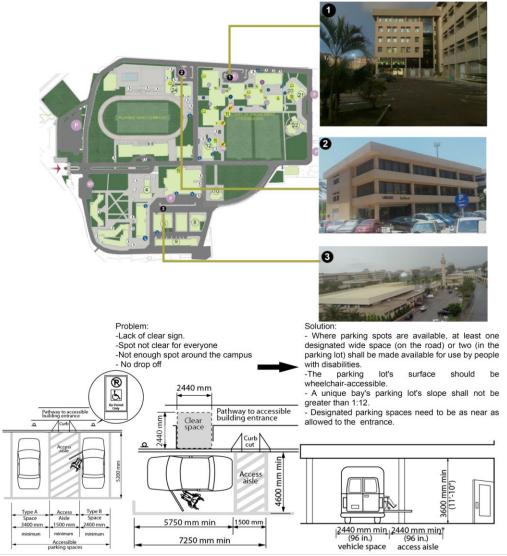
Figure (10): AASTMT's Vehicle Parking [22][23] (Edited by Author)

The type of parking lot is open air as shown in figure (10). There is no height restriction barrier in the parking lot.

Within the parking lot, there are 7 parking bays. The approved parking spaces have dimensions of 350 cm by 500 cm. The allotted berths are the same size throughout in the whole campus. A wheelchair user can get from the parking lot to the building easily due to the ramps and accessibility. There may be a need for assistance due to the ramps. There is no tactile pavement on the lowered curb that separates the building from the parking lot.

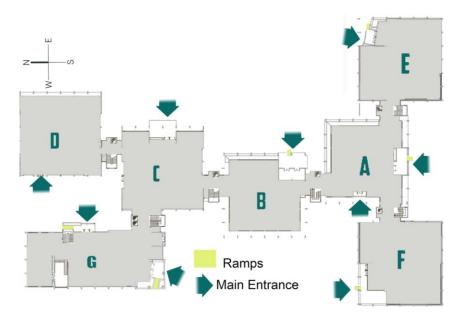
Figure (12): Building plan for entrance, ramps, and steps (By Author)

There are 9 entrance doors to the building as shown in figure (12). The doors are double in number and heavy. The main doors are always open due to the working hours. The doors are double. The average width of the doors opening is 130-150 cm. The doors open up on pull way.

There is a ramp in front of the door in departments A, B, C, F, and G. The grade of the ramp is minimal and permanent. The top of the ramp is not a level landing and there are no railings on the ramp except in building A, as shown in figure (12).

The steps are situated outside the door by 3 steps. The top and bottom of the step are not covered in tactile paving. There are indicated steps. The steps are medium-sized 14cm. There are no handrails on the stairs

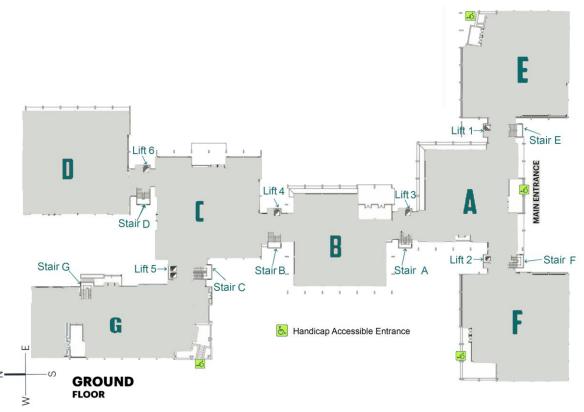
Figure (13): AASTMT's elevators (Edited by Author)

The majority of the building can be accessed with stairs or by using a lift. The stairs are always found in front of the elevators. There are 7 stairs and 7 lifts as shown in figure (13). For building areas, there is obvious signage in the reception area.

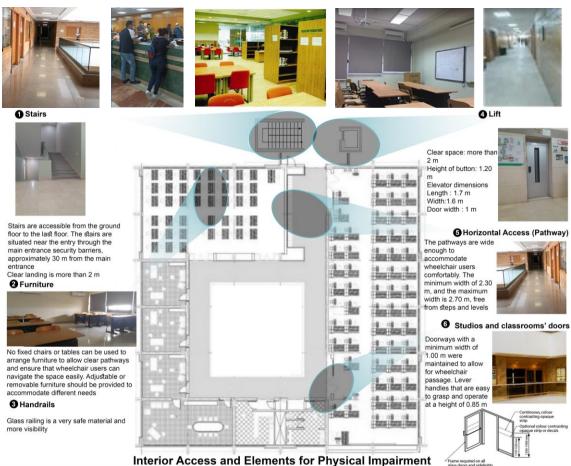
Figure (14): Indoor elements in AASTMT

About average 20 to 30 m separates the elevator from the main door. The clear door is 80 cm wide. The lift is 160 cm by 170 cm in average size. The mirror is present to help with reversing out of the elevator. There is a visual floor indicator in the elevator. The elevator has a medium amount of brightness. There are no Braille markings on the elevator except in the elevator in department F. The lift's controls are between 120 cm from the ground. as shown in figure (14).

In table (3) explaining all elements that are inside the buildings. Most of the places have neither fixed tables nor chairs; have various furniture with suitable dimension that can be useful for user in lecture rooms, library, and cafes. There are clear signs in each room. In the engineering college building there are elevators available in each department near to the entrance. The corridors between departments have width more than 2m. There are accessible toilets in the building. The overhead shelves are higher than 1.30m as shown in figure (14)

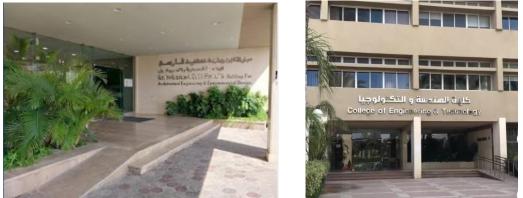
Figure (18): Main Entrance of Engineering Building with clear doors, steps, ramp, and handrails

In table (2) explaining all elements that the building entrance access needs, As shown in figure (18), the main entrance is clear and easy to find but not all the entrances have good accessibility. Lack of signage for non-accessible entrances. All the entrance doors of the building with width more than 1 m. All of them have steps, most of entrances have ramps but not all of them have handrails.

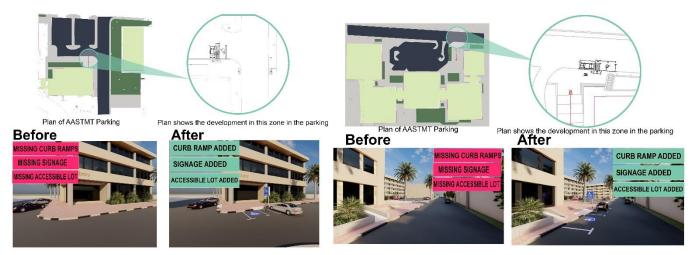
Figure (18): Development of these two parking areas in AASTMT by designing accessible lots

The main problems of the campus is the lack of accessible parking lots with clear signage and curb ramp. these two areas in the outdoor zone of the campus are suggested to be improved by designing accessible lot parking with curb ramp and signage, due to their perfect location near the entrances of the buildings such as engineering building, café, library, and services as shown in figure (18).

- Enlarge the width of the pavement to creat clear lane with 1.2 m without any obstacles
- Create accessible bays with 7 \* 4.5 m with a clear accessible signage for accessibile parking
- Make sure in each intersection of street should have curb ramps with 1:20 slope and minimum 1m width, and the main gate should be easy accessible to all types of impairments to move easily
- Ensure in each entrance to any building should have suitable doors and ramps and steps.
- Provide flexible and different types of furnitures that suiable for all types of students
- Redesigning all counters in camous to contain to different heights
